Gold Coast Mansions & Polished Stainless Steel

BY JEFF KINZLER, Columnist
Long Island Dreamboats Insider

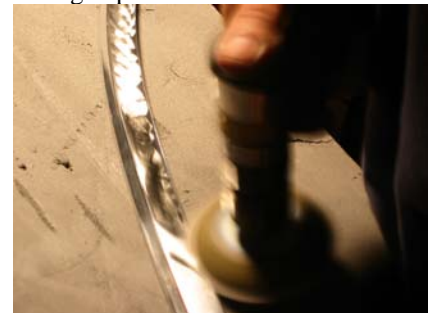
High Speed Sanding Disc

Bobby moved his workshop across the parking lot from the basement to the garage, but had not finished setting it up, so he asked me to come back few days later. When I returned, two of the polishing machines were working. Bobby used a high speed air powered grinder with a three-inch disc to resurface the replacement molding. He restored it as I watched. The first cut was with a 400 grit disc, followed with a 600 grit pad and finally a 1000

until the surface was smooth but dull. Next came the big 1-3/4 HP Baldur polisher with 10 inch buffing wheels. These machines generate serious heat and energy and the operator must wear heavy gloves to hold the work securely and avoid burns.

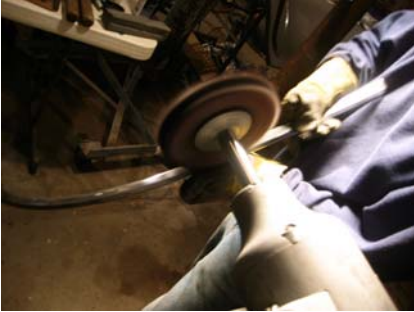
Using the 10 inch Buffing Wheel

Emory buffing compound is used to smooth out the “fog” left by the 1000 grit polishing. Finally a white compound called “rouge” is used on a soft buffing wheel to bring the surface to a mirror shine.

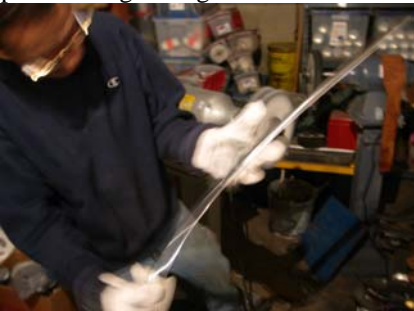
Final Polishing with White Rouge
